SUBMISSION ON ACT WATER SENSITIVE URBAN DESIGN REVIEW 2013

Supplement showing good and poor implementation of water sensitive urban design on road edges

Gillian King

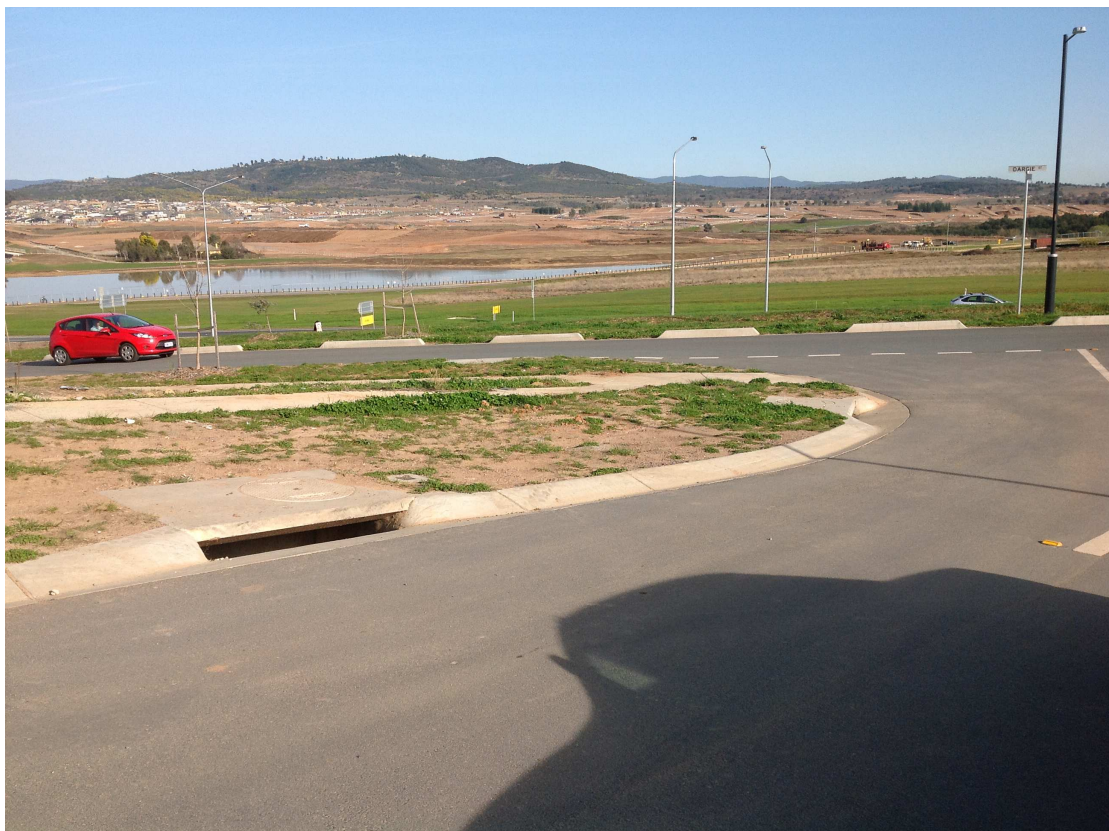
Example 1: Weston – curb on lower side of one carriageway is broken to allow water to soak into soil whereas curb on other side is continuous and directs water into underground stormwater piping (September 2013)

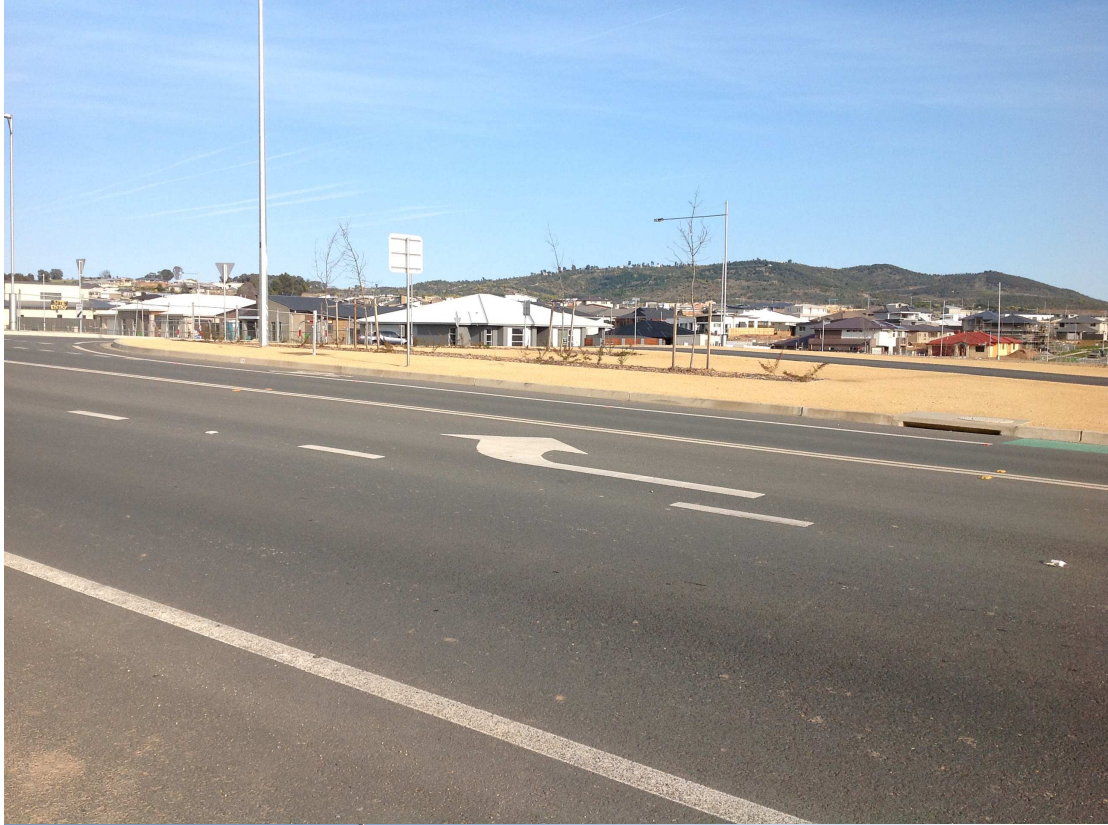
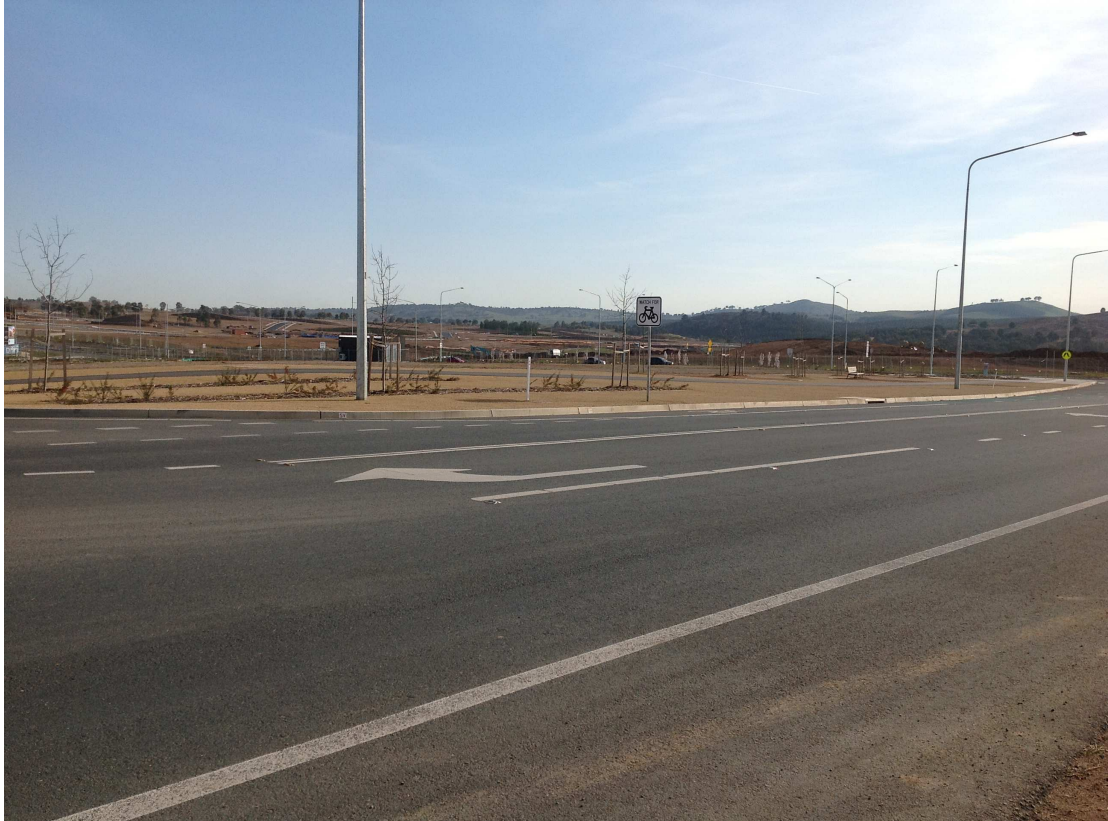
Example 2: Wright – curb on is continuous and directs water into underground stormwater piping. If the curb had been broken and the adjacent soil level made lower than the road (to create a rain garden), rainwater could have been directed to water adjacent vegetation and the cost of continuous curbing and underground stormwater system avoided. Note that the second picture shows no curbing on the opposite side of the carriageway. (September 2013)

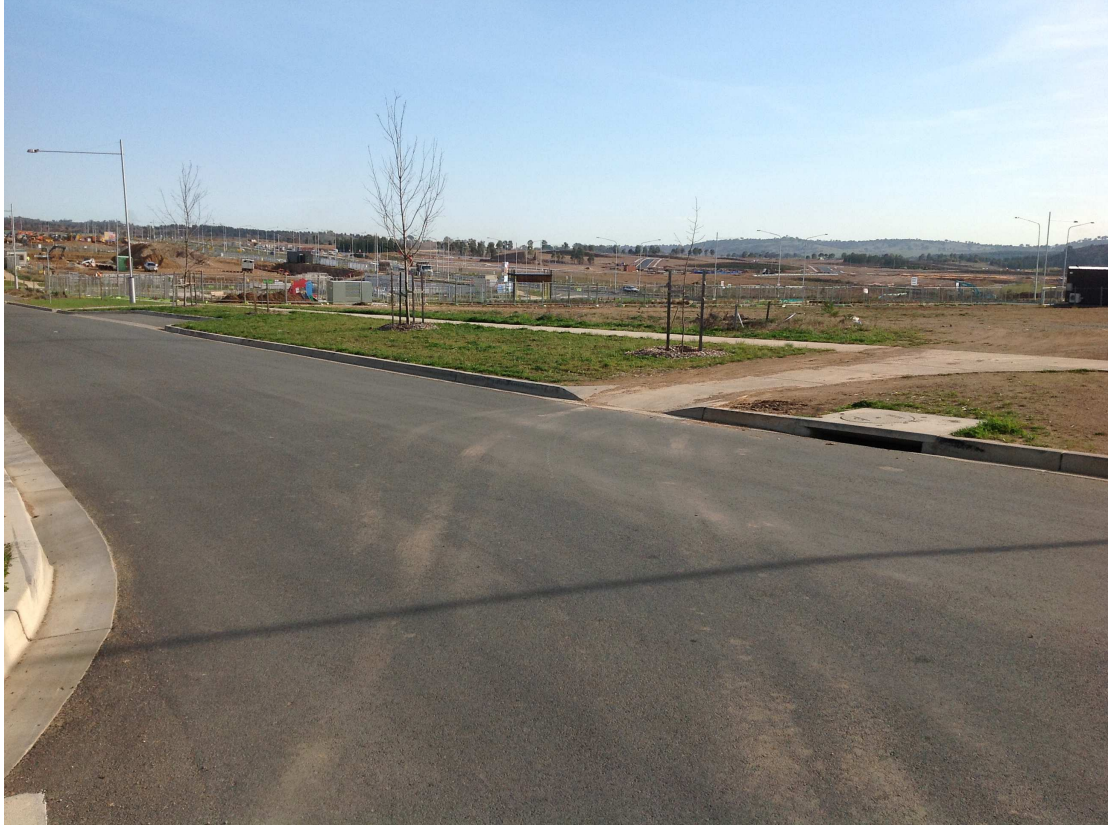
Example 3: Wright – curb is continuous and directs water into underground stormwater piping. If the curb had been broken and the adjacent soil level made lower than the road (to create a rain garden), rainwater could have been directed to water adjacent vegetation (benefitting both vegetation and home occupants) and the cost of continuous curbing and underground stormwater system avoided. (September 2013)

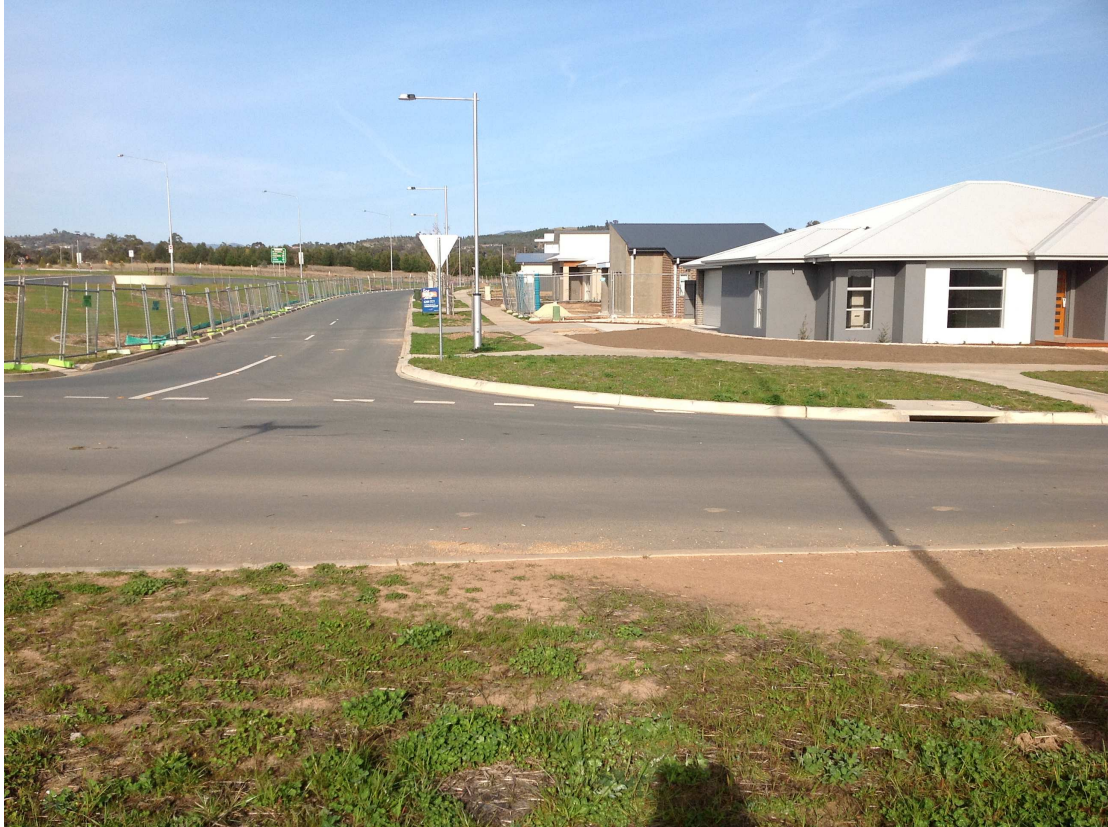
Example 4: Wright – two sides of one street, each with different curbing. Curb on (slightly higher) side of street is broken and directs rainwater to vegetation. Curb on other side of street is continuous and directs water into underground stormwater piping. If the curb had been broken and the adjacent soil level made lower than the road (to create a rain garden), rainwater could have been directed to water adjacent vegetation (benefitting both vegetation and home occupants) and the cost of curbing and underground stormwater system reduced. (September 2013)

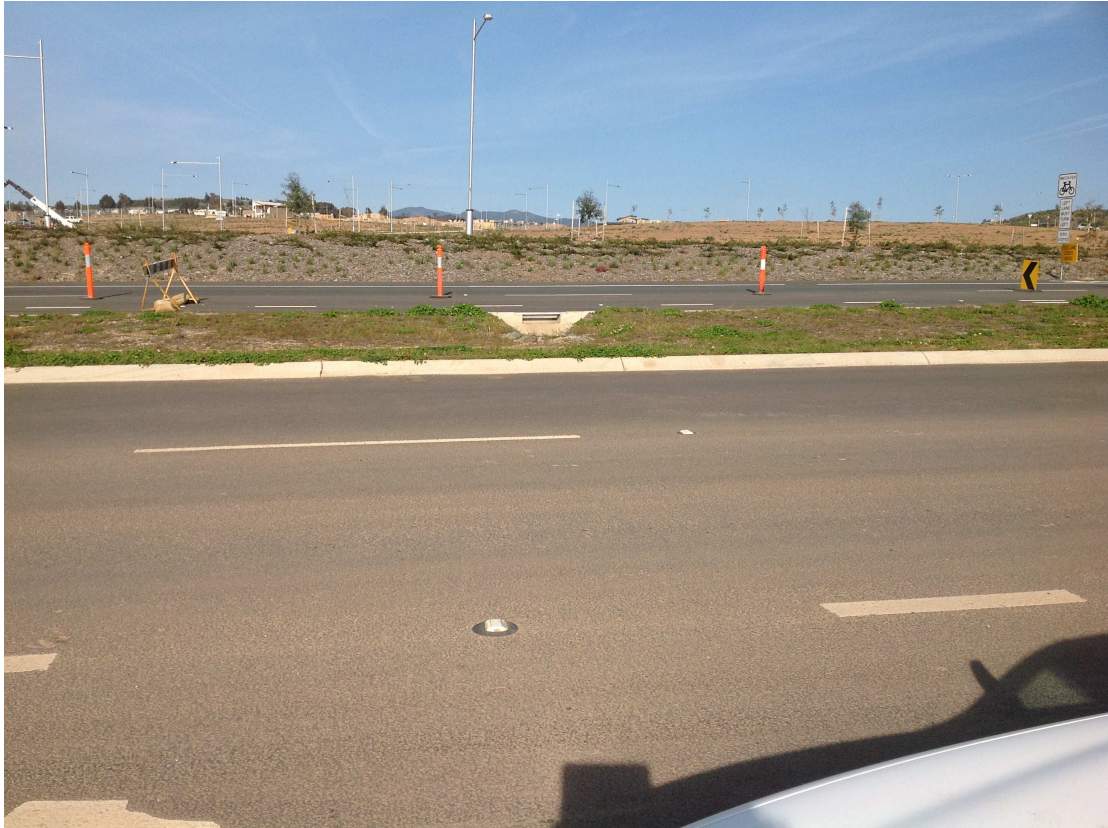
Example 5: Wright (John Gorton Drive) – different treatments on opposite edges of dual carriageway median strip. Curb on high side of median strip directs rainwater to swale in median strip; curb on other side of median strip is continuous. (September 2013)

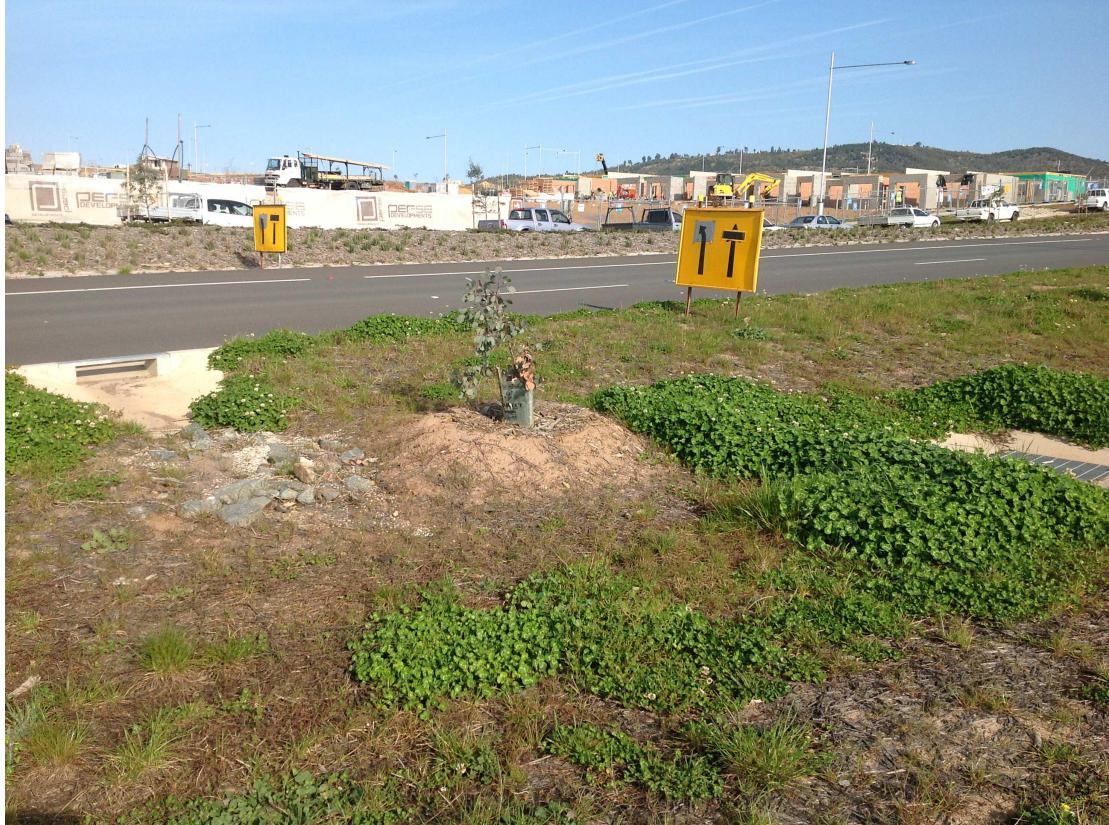
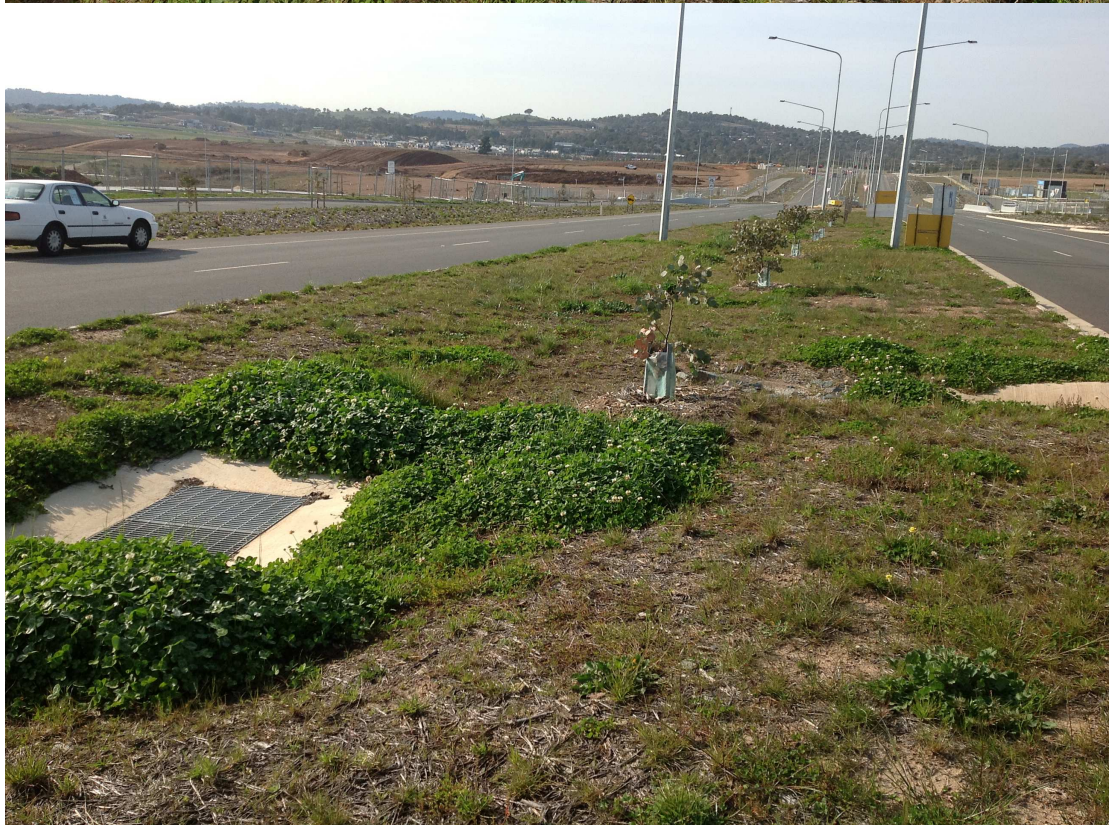
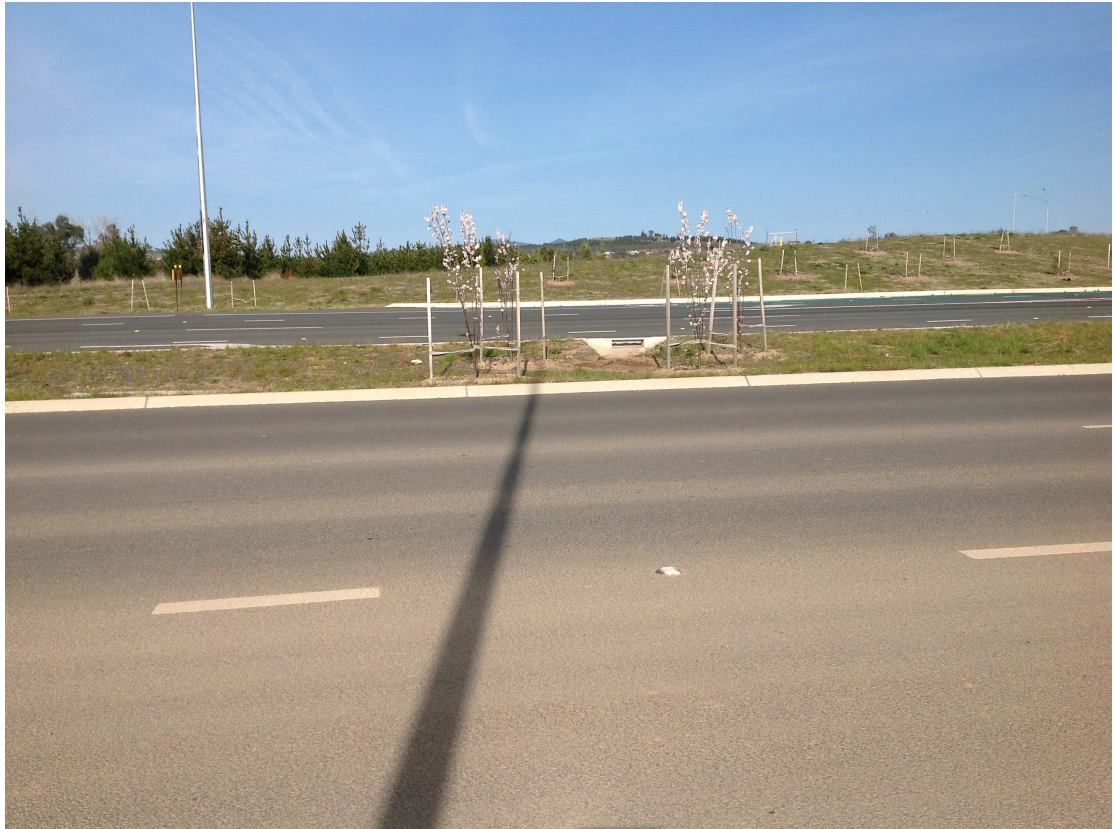
Details of median strip swale with trees, showing how trees are planted. They are planted on raised mounds (presumably to provide the trees with extra drainage) and located at lower end of where water runs into the swale. The picture immediately below shows a tree that is also adjacent to a rainwater pit (presumably connected to underground stormwater pipes).

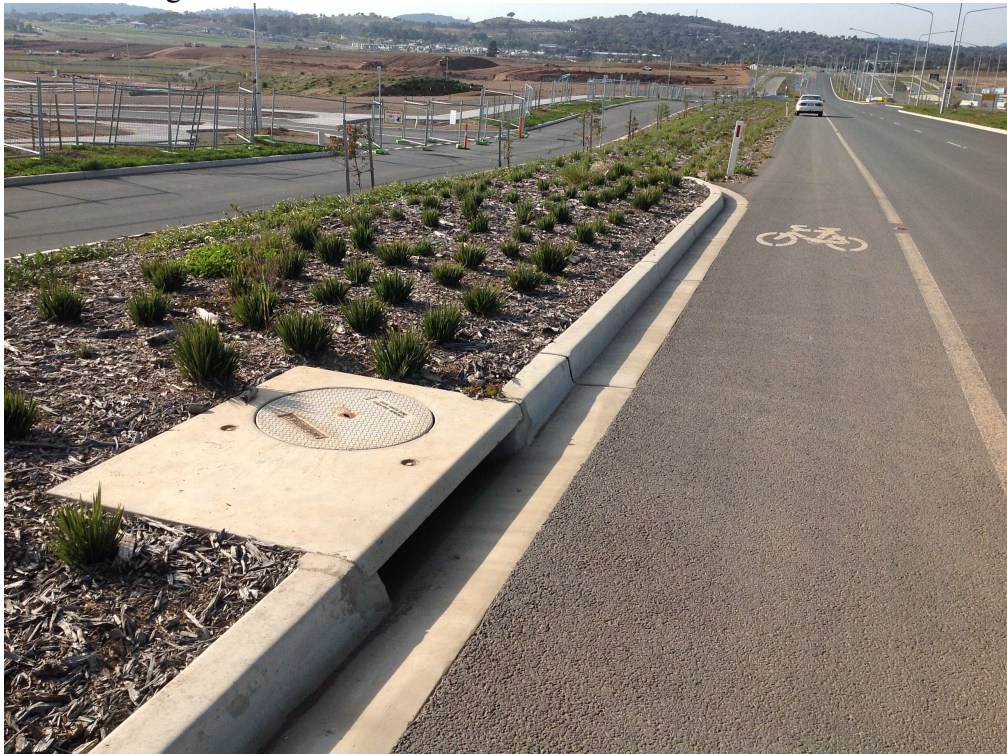
6(a) Continuous curbing keeps vegetation above road surface (and water from the road) and directs water into underground pipes. A short distance away the same curbing – and then just the road surface – direct water into the median strip, where it can water vegetation.

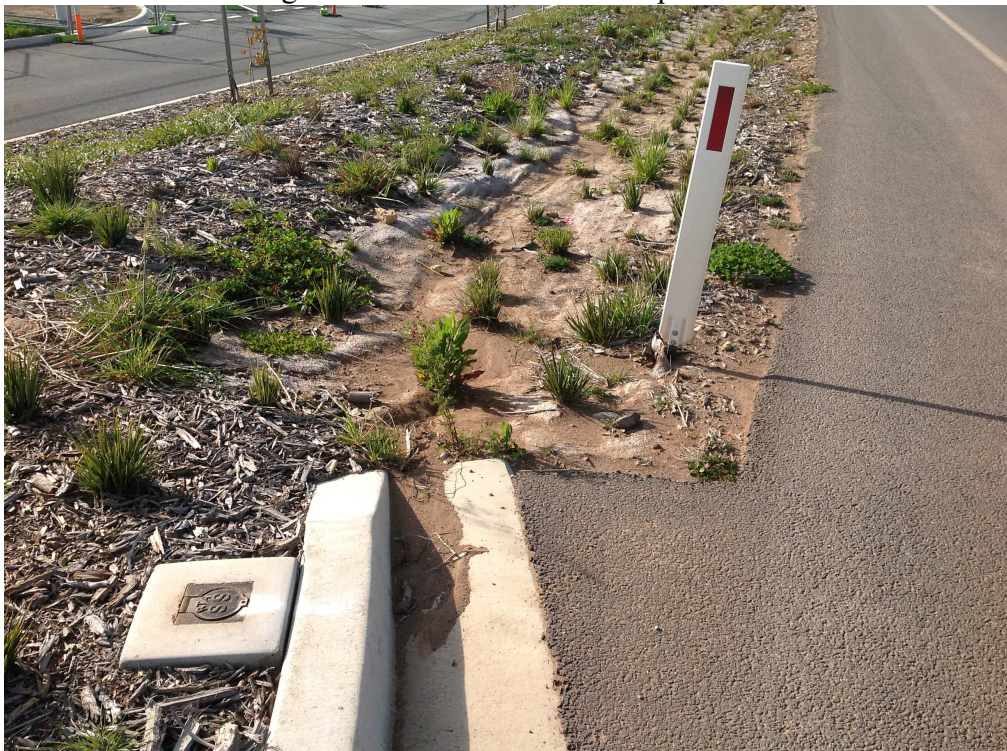
Detail of end of curbing and median strip between dual carriageway and service road; note continuous curbing on other side of median strip.

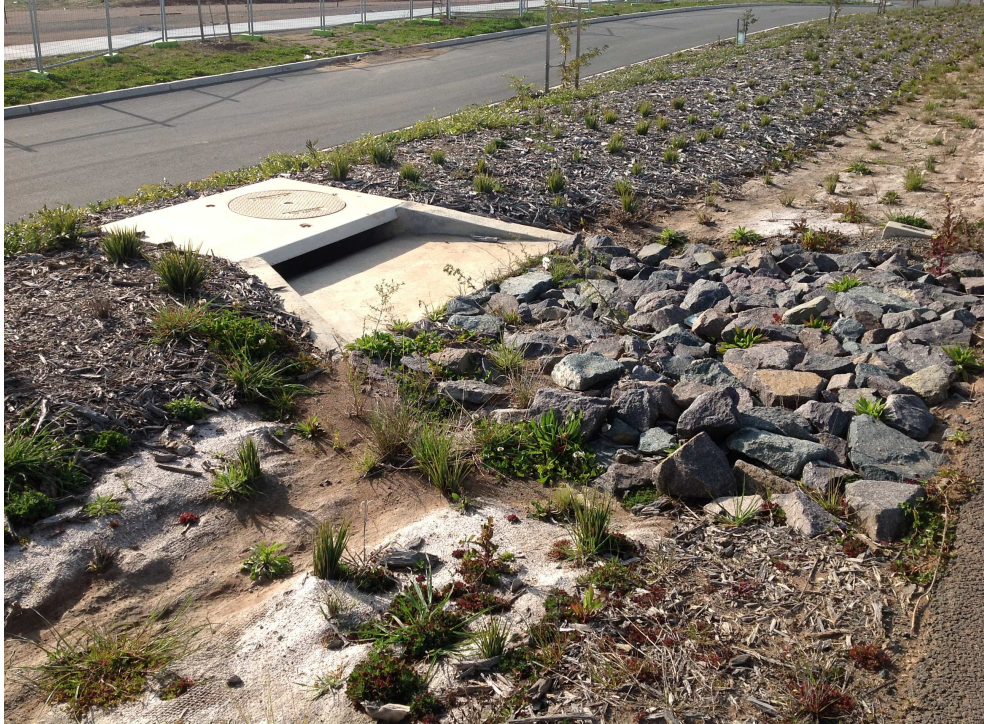
6(b) Entry to stormwater system from continuous curb on service street side is in line with higher soil level. Its 'back' side is open at the lower level of the swale on the main carriageway side, presumably to allow for swale overflow. However, the design of the swale and its height relative to the stormwater entry suggest that a lot of rain runs directly into the stormwater system instead of soaking into the ground – as can be seen by the runoff marks in the swale soil.

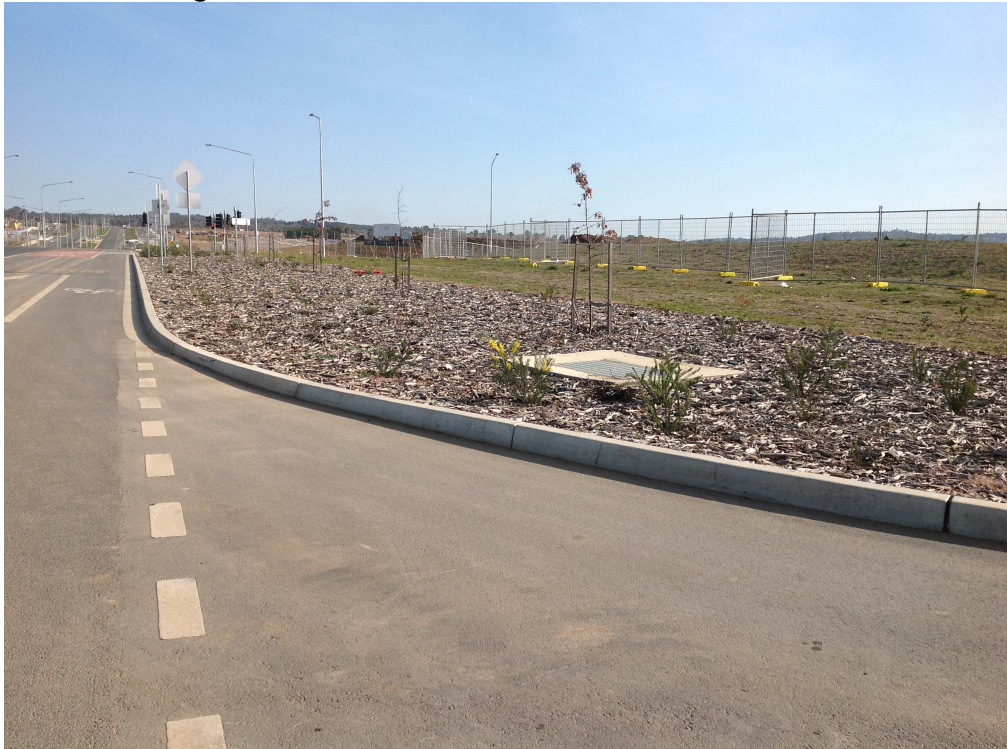
6(c) Continuous curbing along outer edge of service road. The type of planting and mulching suggests the verge has been designed to be water-wise and low maintenance – but it may have been more so (and cost less) if it had been built as a rain garden instead of being raised above the road surface.

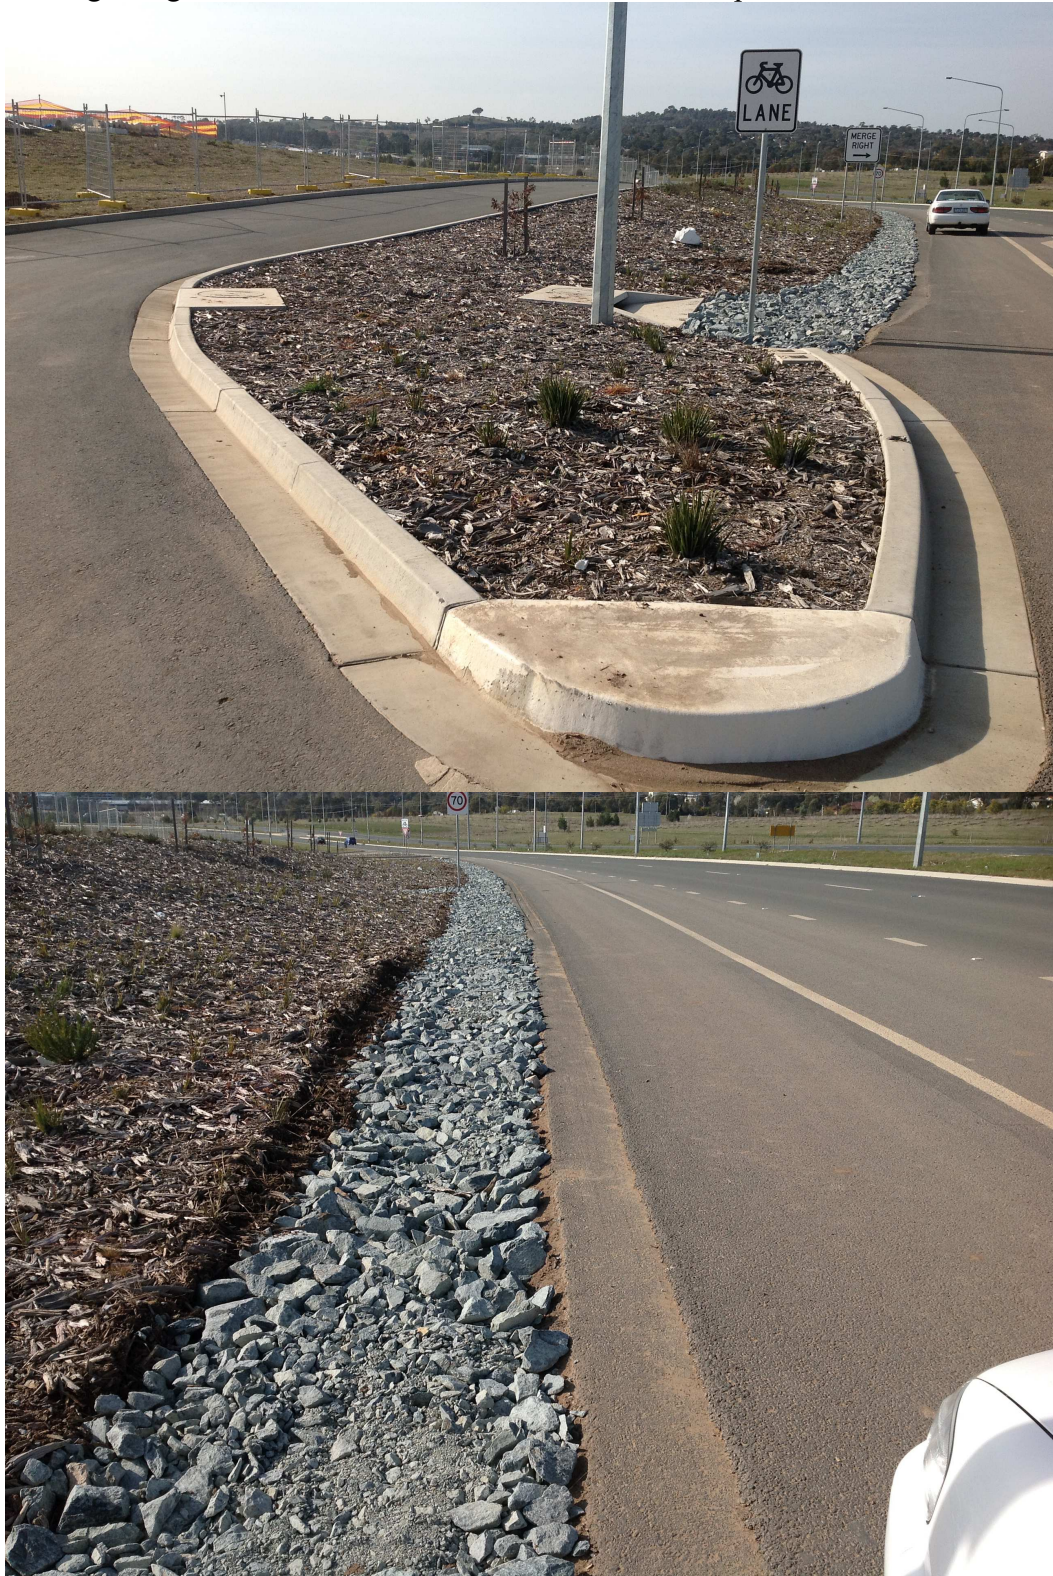
6(d) A third type of road edging along the main carriageway. Here, the swale along the road edge is covered with crushed rock, presumably to facilitate water soaking into the soil. The entry to the underground stormwater system from the swale is higher than the crushed rock, allowing it to handle swale overflow only – unlike in example (b). On the other hand, the detail of the construction of the crushed rock surface and its edge with the mulch suggests that there will be some surface wash and the crushed rock will become clogged with finer particles. Note the continuous curbing along the service road and end of the median strip.

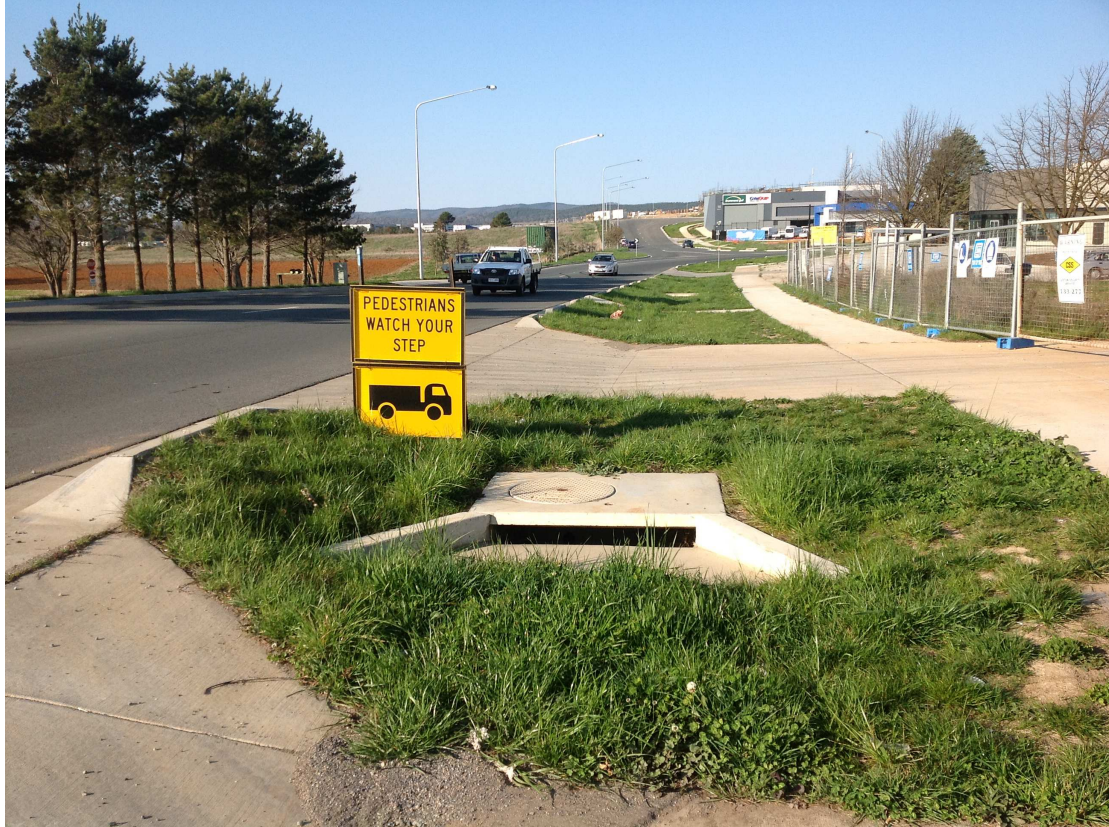
Example 7: Wright – entry to underground stormwater system from nature strip that is lower than the road surface and has broken curbing. This appears to be an attempt at combining water sensitive design with conventional stormwater management. The foreground of the picture suggests that there could be some maintenance issues for residents once they move in. (September 2013)

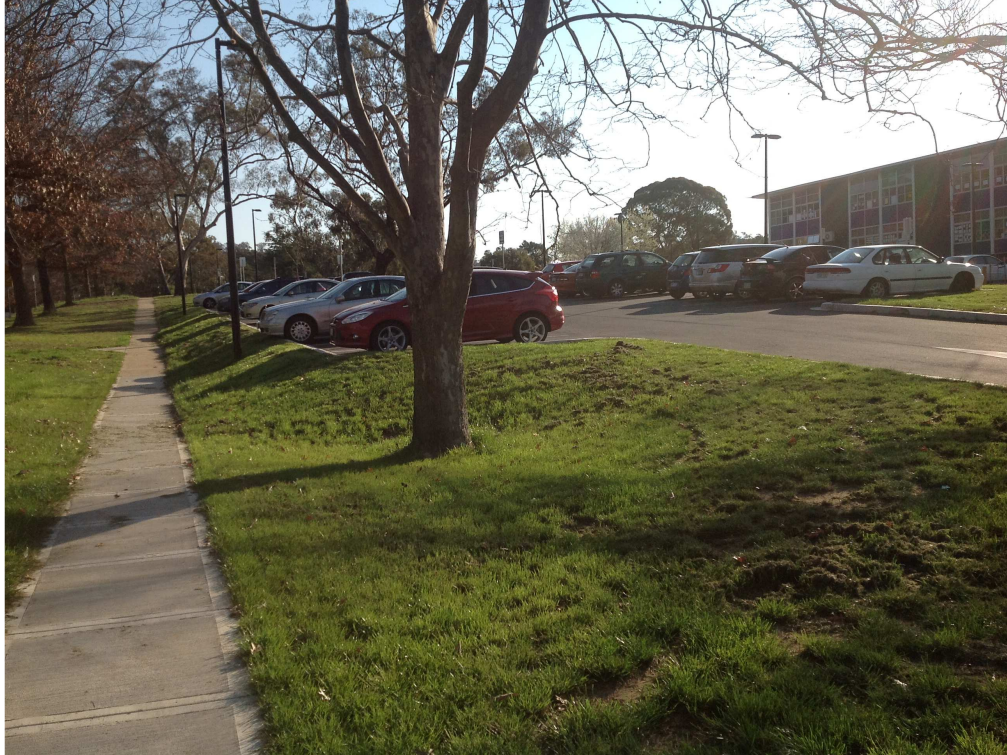
Example 8: Red Hill (Red Hill Primary School) – carpark constructed in manner that directs water away from trees. This carpark was built above the previous (probably natural) level of the land. It was hard-paved and continuously curbed. These measures rob the existing mature trees of water to which they previously had access via a grass surface. (September 2013)

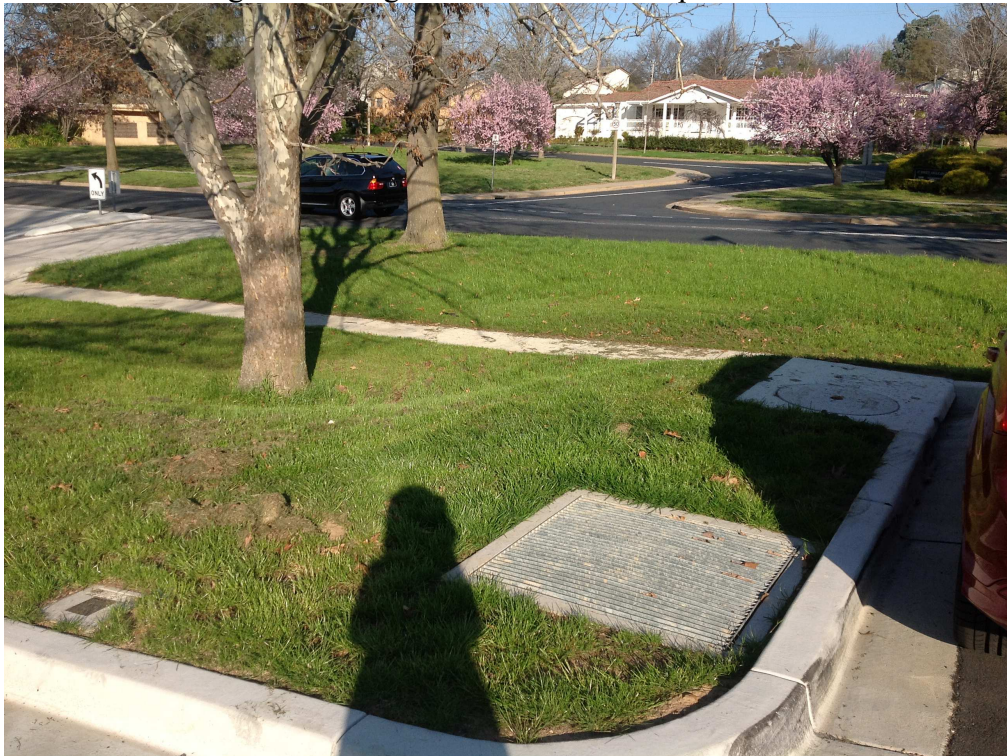
The continuous curbing feeds rainwater into the underground stormwater system. How much better for the trees and budget would it have been to have broken curbing feeding water to the trees? And how will the very highly-placed stormwater pit behind the curbing in the foreground ever collect surplus runoff?

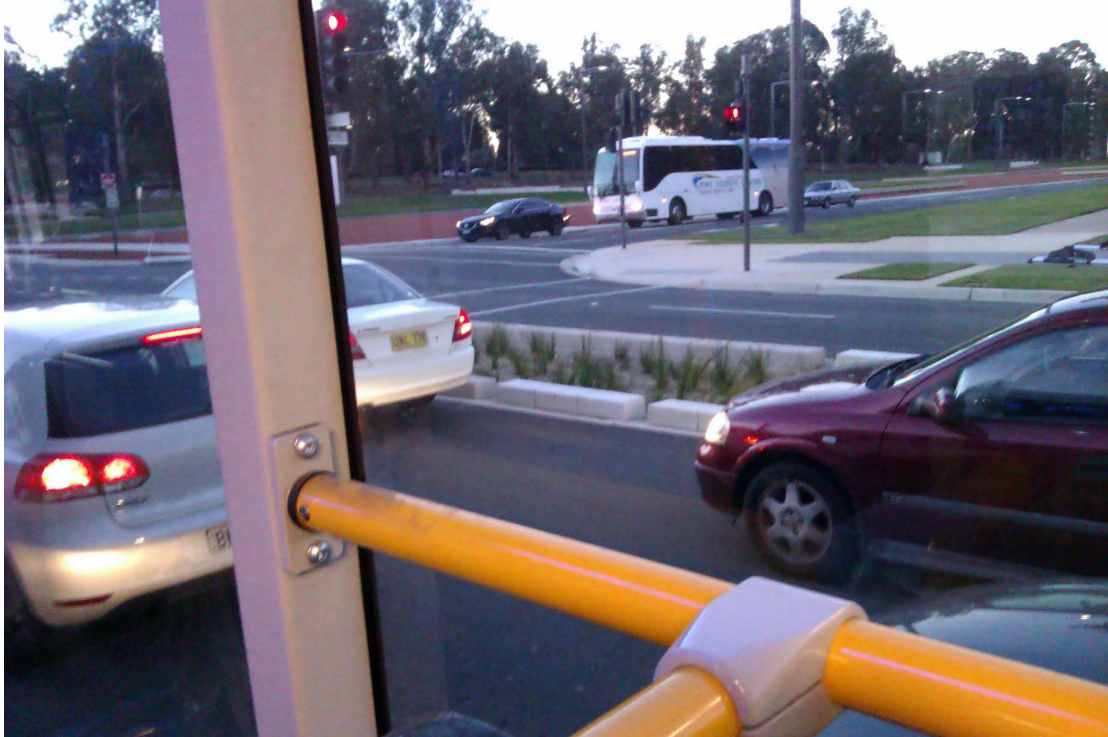
Example 9: Campbell (Constitution Avenue) – broken curbing allowing rain water to feed into the median strip, which has been constructed as a rain garden lower than the road surface. Similar treatments have been retrofitted to traffic islands in Melbourne (picture from Hampton, City of Bayside has been lost). Note, in contrast, continuous curbing on outer edge of carriageway. (August 2013)

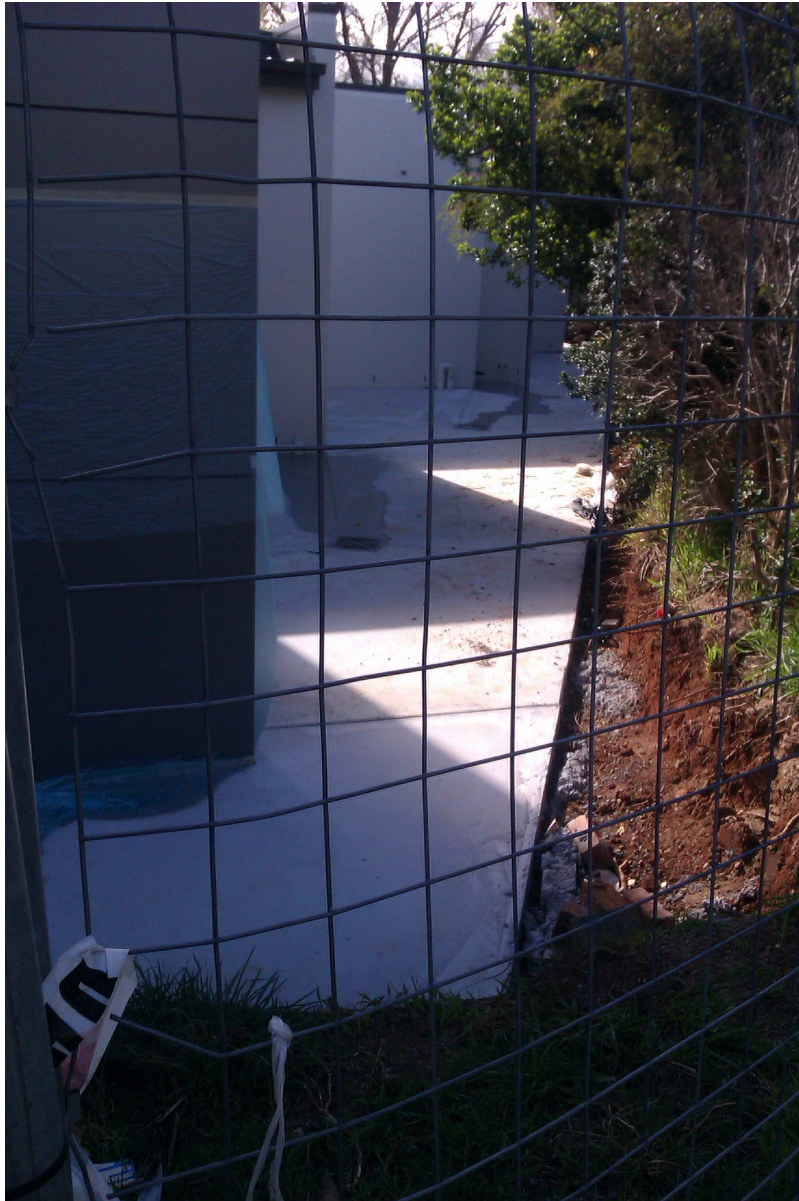
Example 10: Griffith – back yard of new house (in mature suburb) has been lowered then paved in concrete, with water directed to stormwater pits and then to underground stormwater system. There is no provision for water to soak into the ground or in-ground vegetation to moderate the weather on this side of the house. Vegetation on the neighbouring block has lost a lot of its source of water. Similar continuous hard-paving of back yards (but on a much larger scale) is found in other re-developed single dwellings in the suburb.
